Our current exploits in Togo

The Route

- 606 Km's (OPGW, OPPC)
- Link the Backhaul to the CLS, and enable connectivity from EQUIANO to unlock Togo and the North of Togo, Benin, Burkina Faso.

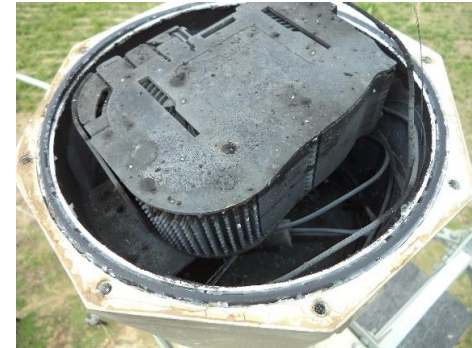
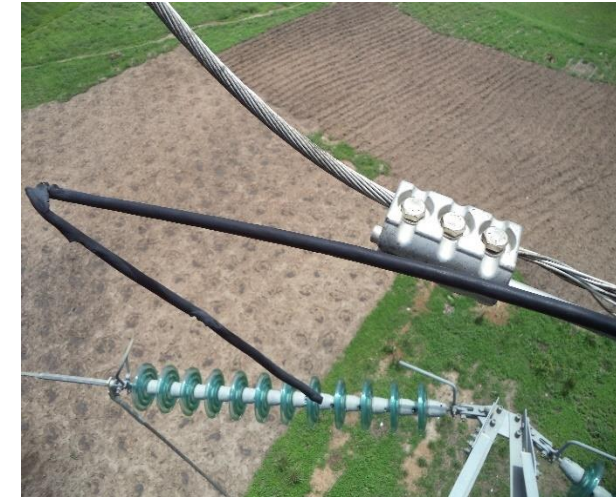
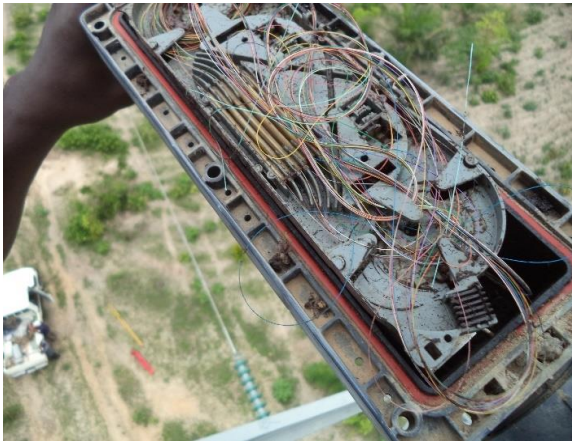
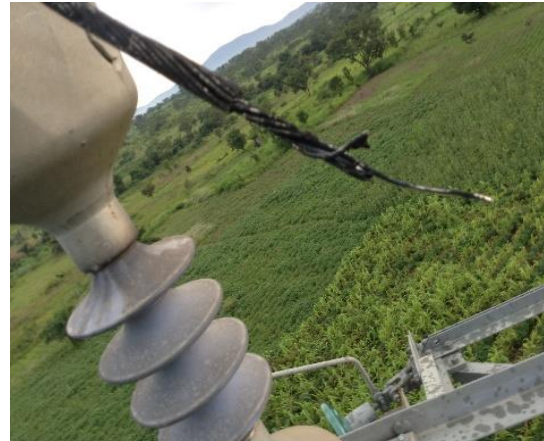
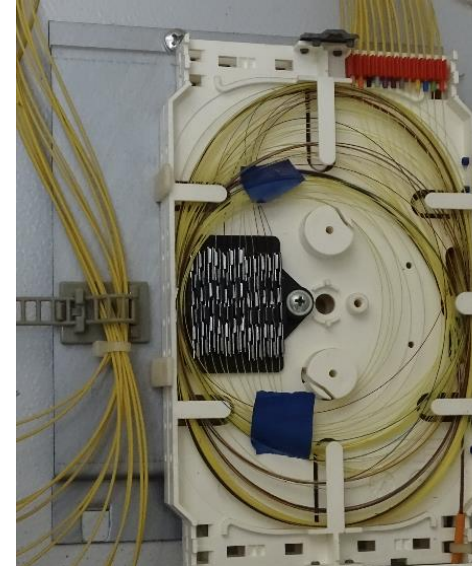
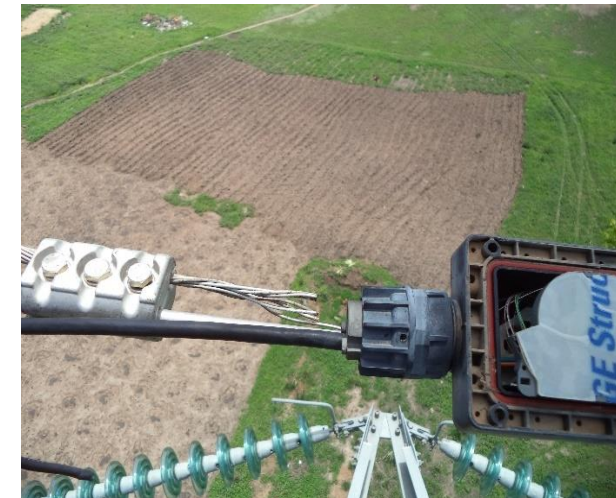
Some of the issues

- Bee Nests
- Bad Installation of OPPC Surge Arrestors
- Mechanical Splices in ODF Cabinets
- Dry Band Arching at Breakout Points
- Broken Fibres Mid Span
- OPPC slippage, Phase To Ground Arc Over
- High Attenuation, due to ODFs, UG Cable, Bad inline Splicing, cheap products recommended at design stage and later incorporated at build stage.
- The Fix (Remediation of all Joints, replacing of ODFs, Pigtails, some Fibre Optic Joint Surge Arrestors), replacement of most OPPC joints due to weathering, contamination and bees.

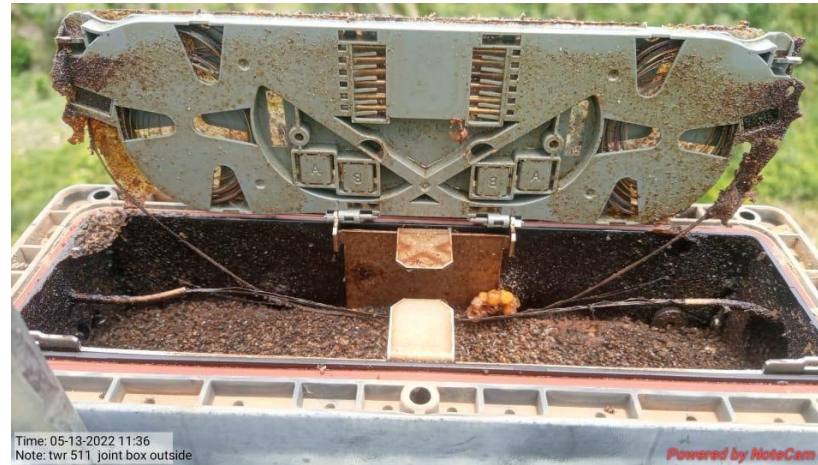
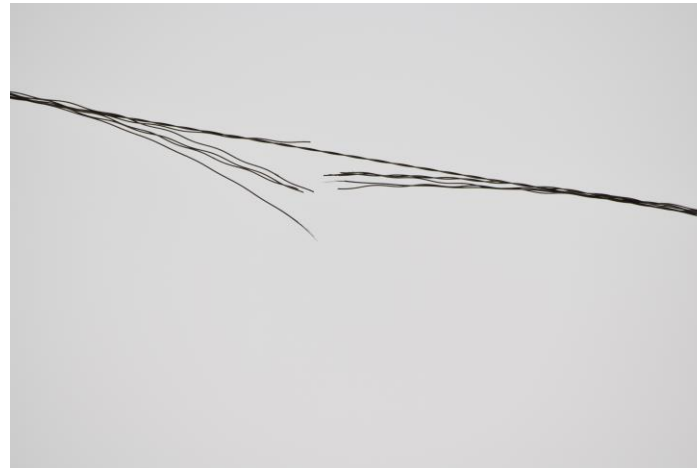
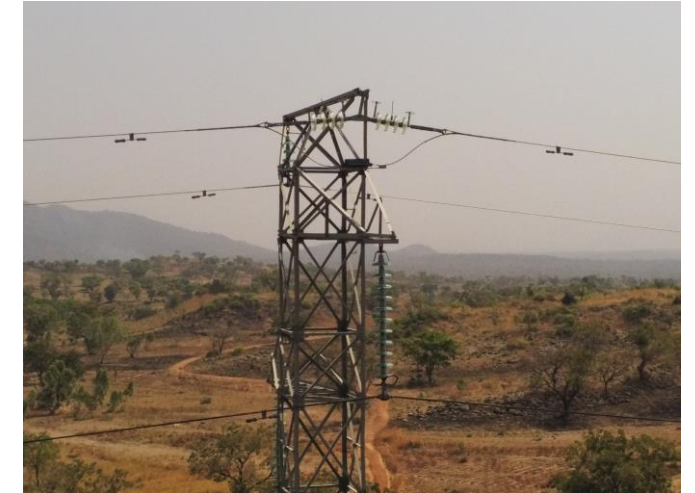
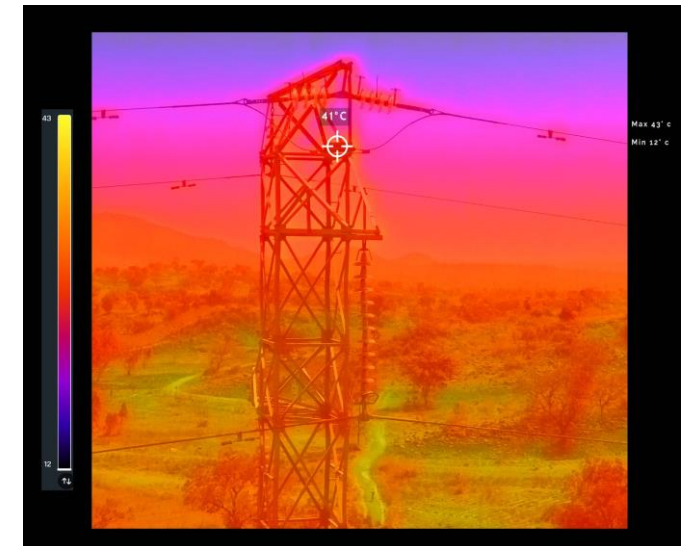
DTS & Drone Verification

We were able to distinguish bee nests with distributed temperature fibre sensing, then classify it with a drone (Thermal).

DTS Profiled normal ambient temperature on the Joint Enclosure at an average 26°C where Bee Nests were not present.

Where Bee Nests were known to be present, the Ambient Temperature on the Joint Enclosure varied between 37 °C to 44 °C
