Our current exploits in Togo

The Route

- 606 Km's (OPGW, OPPC)
- Link the Backhaul to the CLS, and enable connectivity from EQUIANO to unlock Togo and the North of Togo, Benin, Burkina Faso.

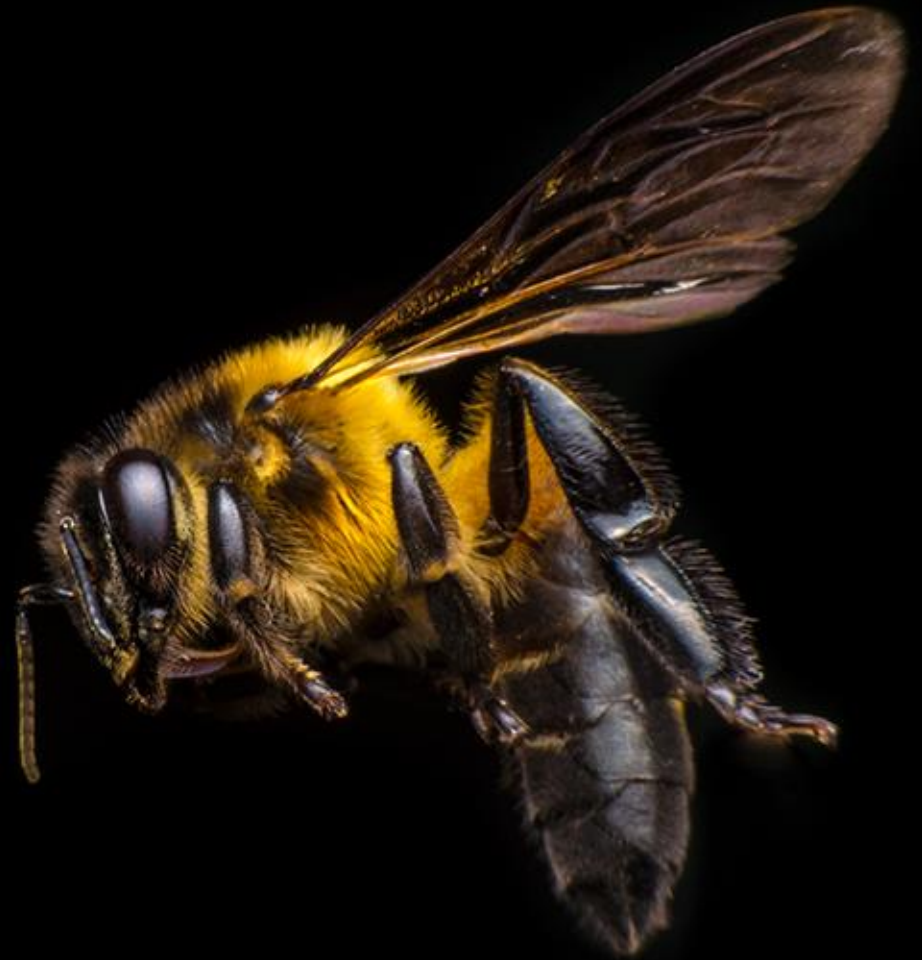
**Some of the issues
we encountered...**

Some of the issues

- Bee Nests
- Bad Installation of OPPC Surge Arrestors
- Mechanical Splices in ODF Cabinets
- Dry Band Arching at Breakout Points
- Broken Fibres Mid Span
- OPPC slippage, Phase To Ground Arc Over
- High Attenuation, due to ODFs, UG Cable, Bad inline Splicing, cheap products recommended at design stage and later incorporated at build stage.
- The Fix (Remediation of all Joints, replacing of ODFs, Pigtails, some Fibre Optic Joint Surge Arrestors), replacement of most OPPC joints due to weathering, contamination and bees.

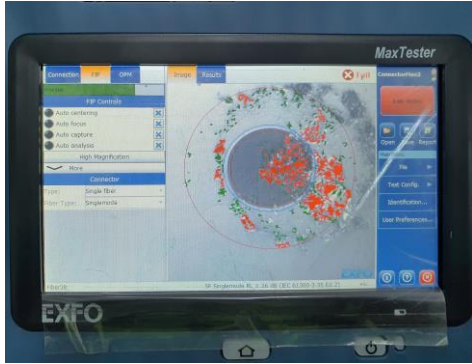
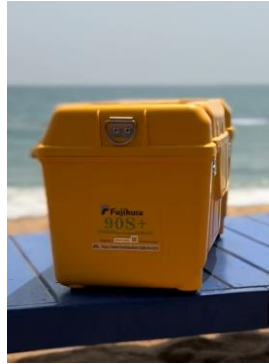
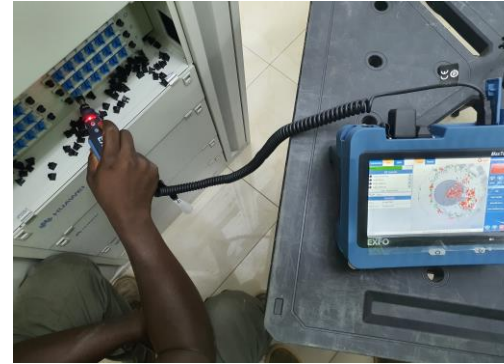
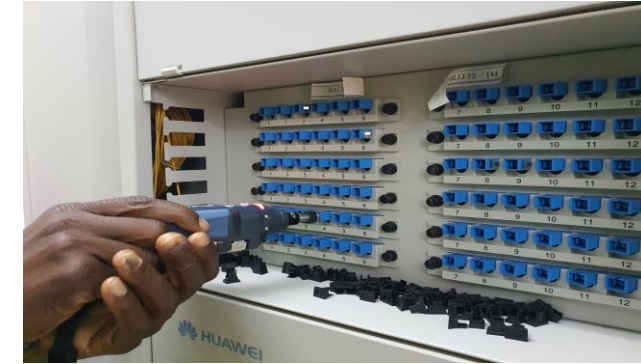
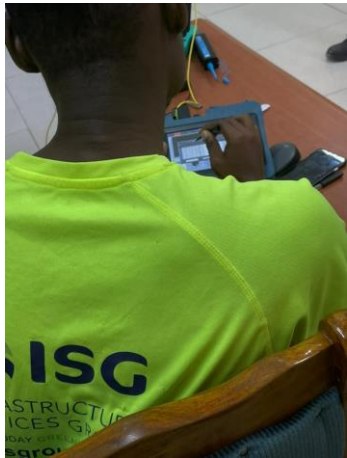
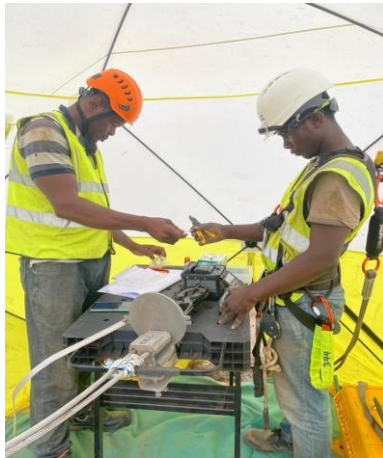
The Right Equipment, Makes a Huge Difference

Cable Overlay on Damaged OPPC, using AFL's Skywrap PhaseWrap Cable on 34kV Rated OPPC
